Daiwa CN901V N directional wattmeter

technical analysis

IKOBGG Jan. 2021

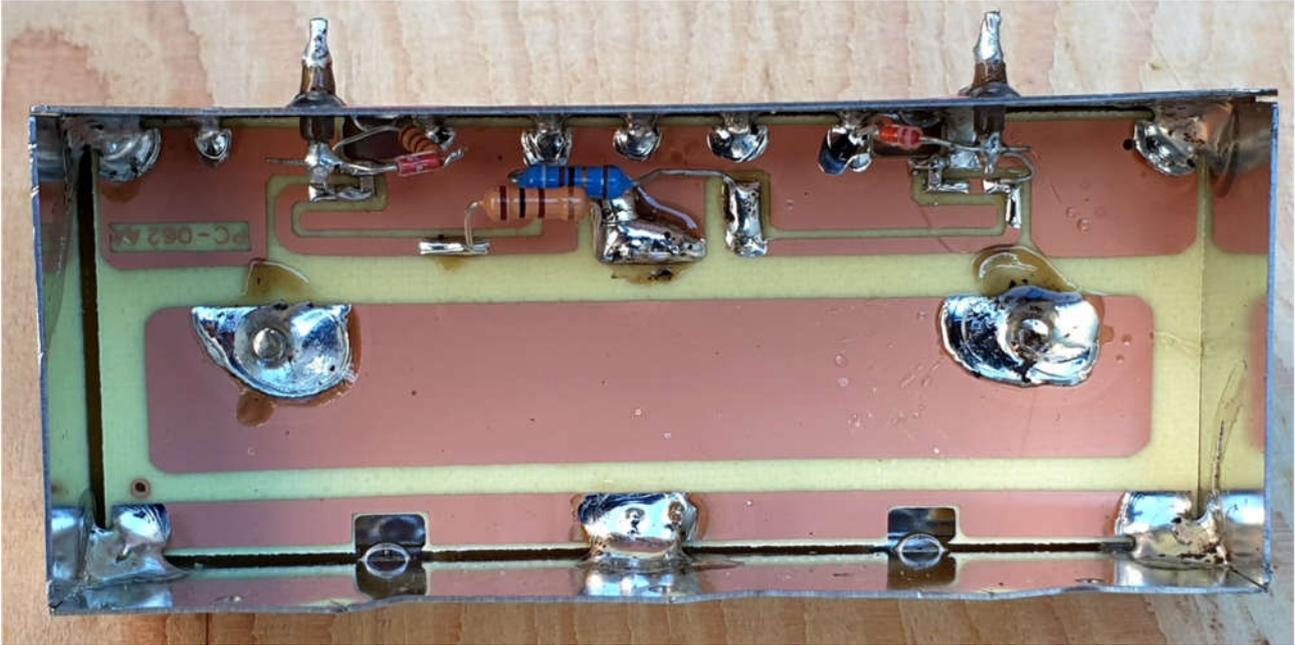
Here is what the directional coupler looks like once the cover is removed:

- a suspended microstrip main transmission line links together the two N input and output connectors.
- two other microstrip transmission lines realize the directional couplers of the forward power (left) and the reflected power (right)

One may immediately notice the realization characterized by solder paste residues, excess tin, tiny little tin balls walking throughout the box.

At a first look one is impressed by the two couplers - that should be designed to operate up to over 500MHz - manufactured like an audio frequency circuit: the components are left with long leads.

There are long leads in order to make possible the calibration of the unit by changing the components' position by acting with a dielectric tool from the outside through the alignment slot. By moving the components one can obtain a power calibration but the consequence of the distorted coupler's topology and the lead's parasitic parameters is a very poor directivity, especially on the 430MHz band; as a result SWR readings are erratic.

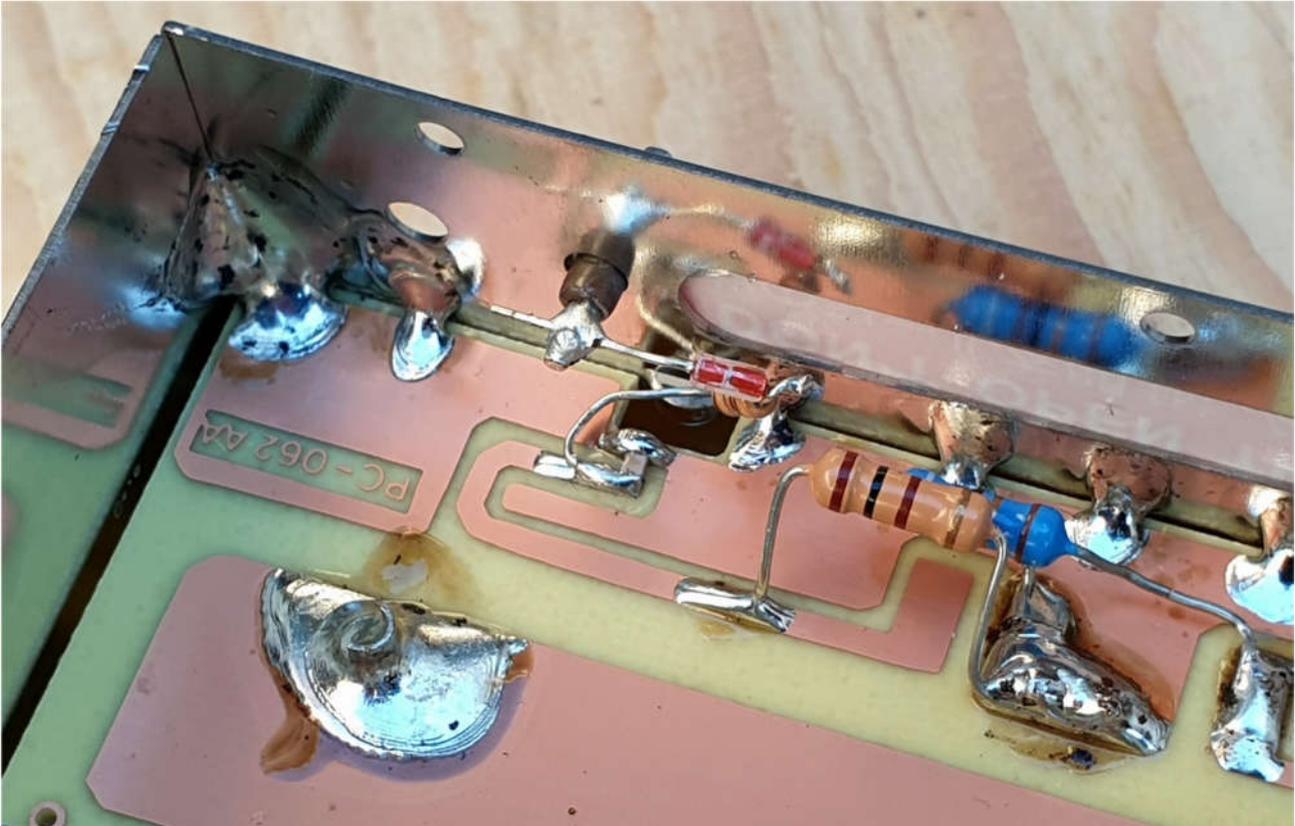
The 100 ohm 0.5W resistor has long leads in order to be moved during the alignment process, the left lead is also connected to a weird place: it is soldered to the center of the microstrip instead of being connected to its land which, of course, has been left free.

The 150 ohm resistor which is in series with the diode has an excessively long lead connected to the microstrip and it has been clearly moved when calibrating.

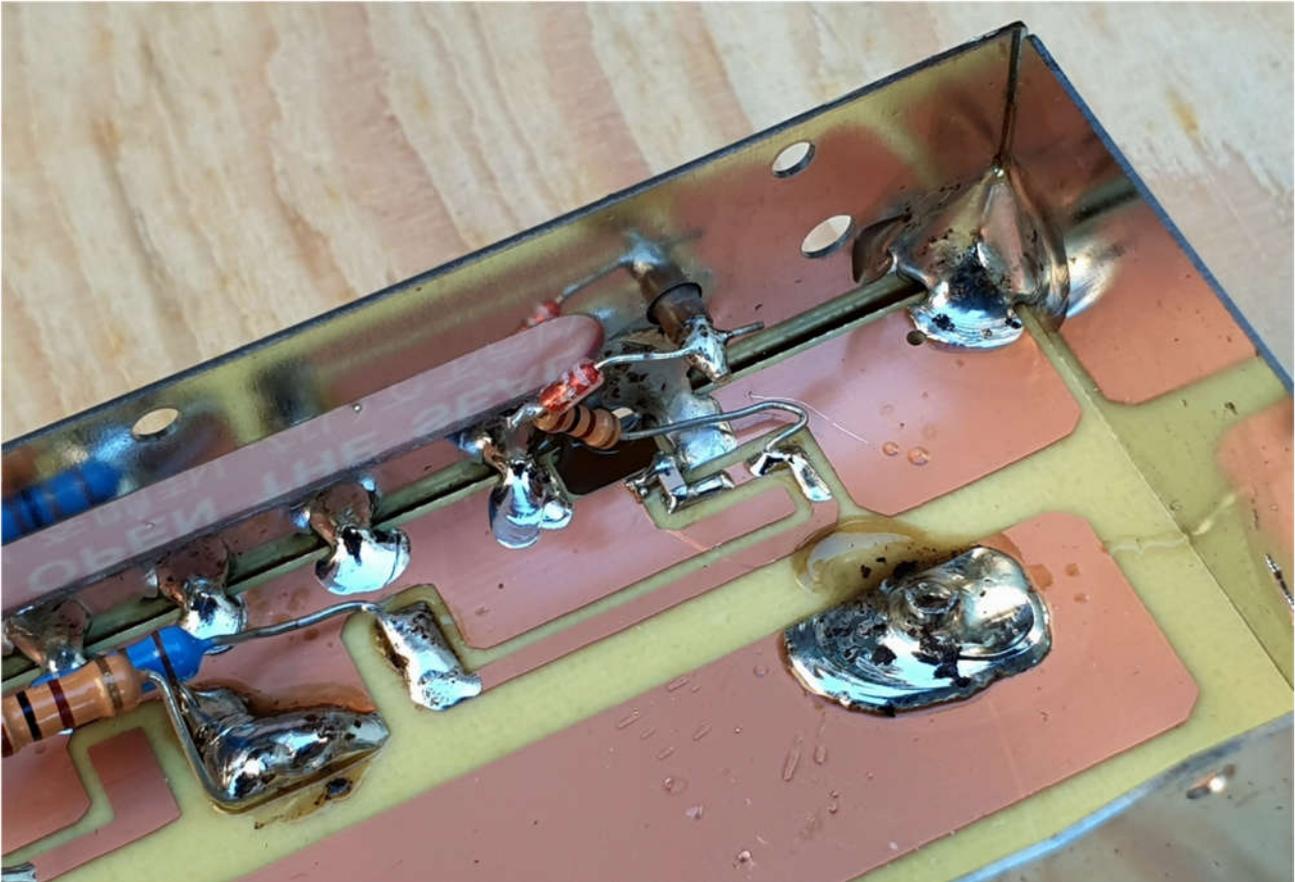
The 91 ohm 0.5W resistor (the blue one on the left side) has its right lead soldered to the right land (unlike the forward coupler one) but it is excessively long in order to move it while calibrating. The 100 ohm resistor (on the right and in series with the diode) has the lead connected to the microstrip that are very long and wandering. The welding of the pin of the coaxial antenna connector to the passing microstrip line is made with an excess of tin and with the solder paste and dirties that has not been removed; solder residues are interposed between the main line and the reflected power coupler's line.

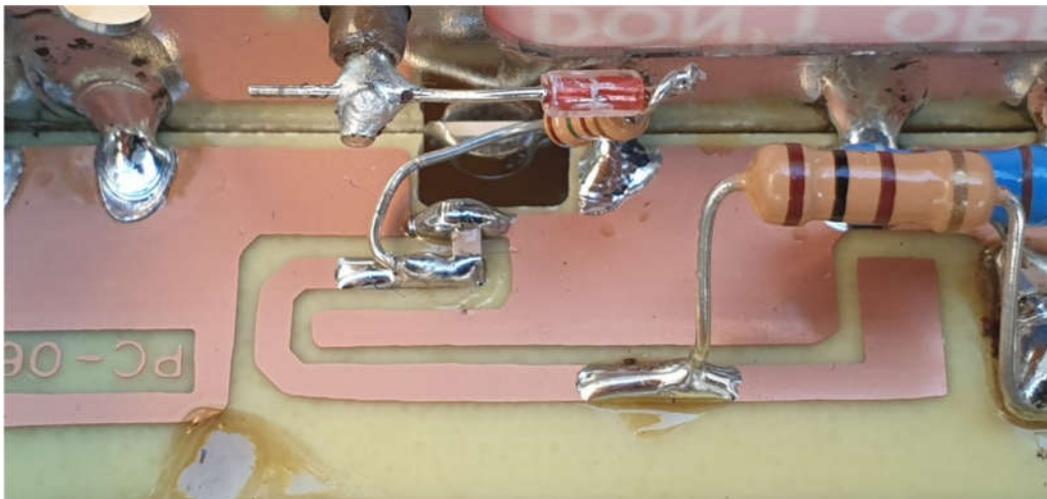
By carefully watching the coupler's detail one can deduce that it seems to have been designed by hand drawing! In fact the coupler's line width is not constant and also the other traces have not been accurately drawn.

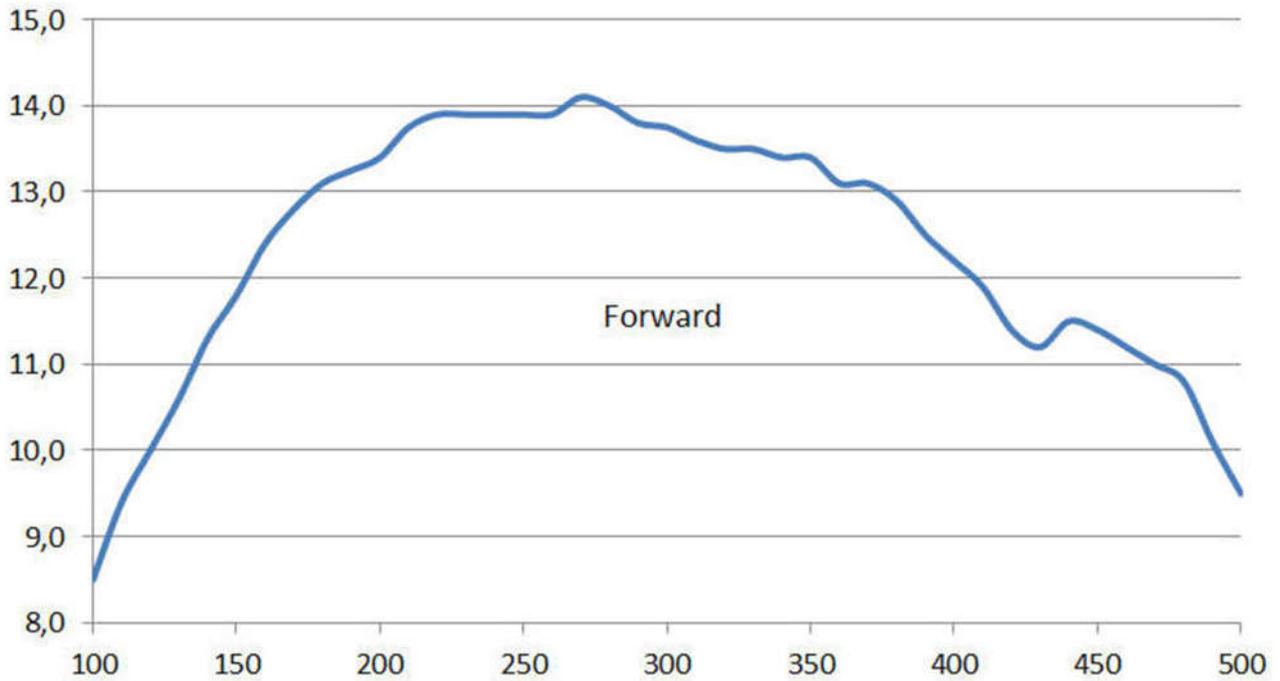
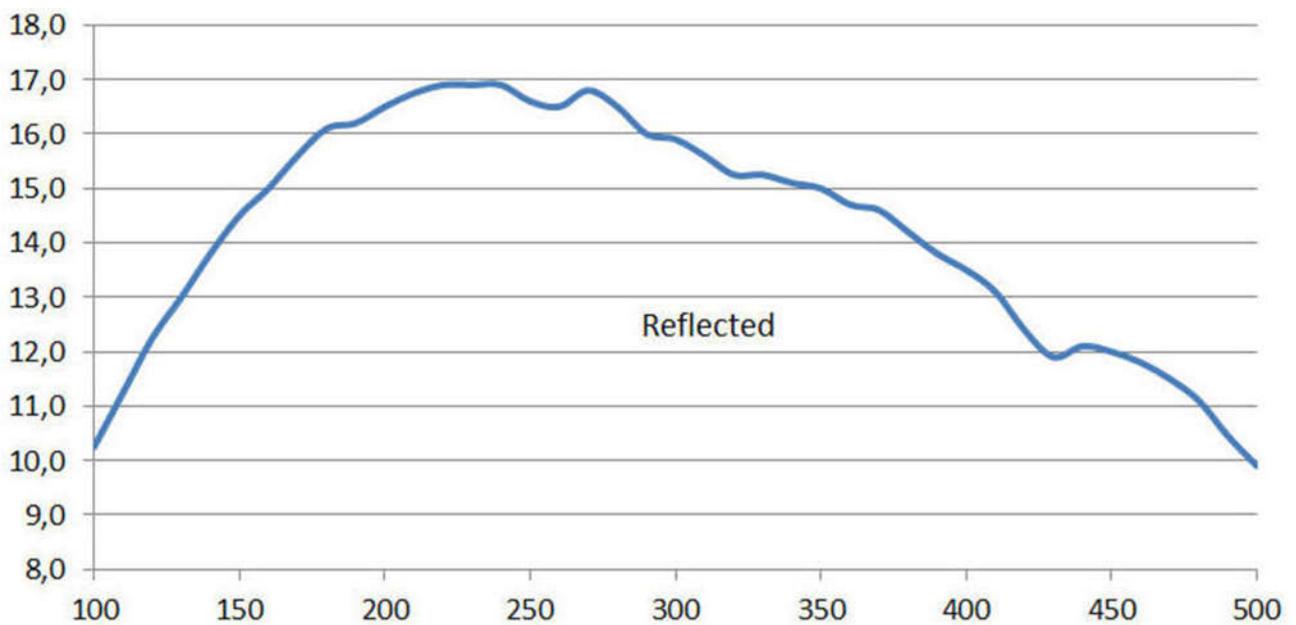
The coupler performances have been measured by feeding the unit with a signal generator and reading the output voltage, in relative units, as a function of the frequency; here are the forward and reflected power characteristics that have the same amplitude only in two points: 145 MHz and 435 MHz amateur bands.

Since the power is proportional to the square of the voltage, the accuracy of the power readings outside the above two amateur radio bands is completely out of specs.
