Daiwa CN901V N directional wattmeter

technical analysis

IKOBGG Jan. 2021

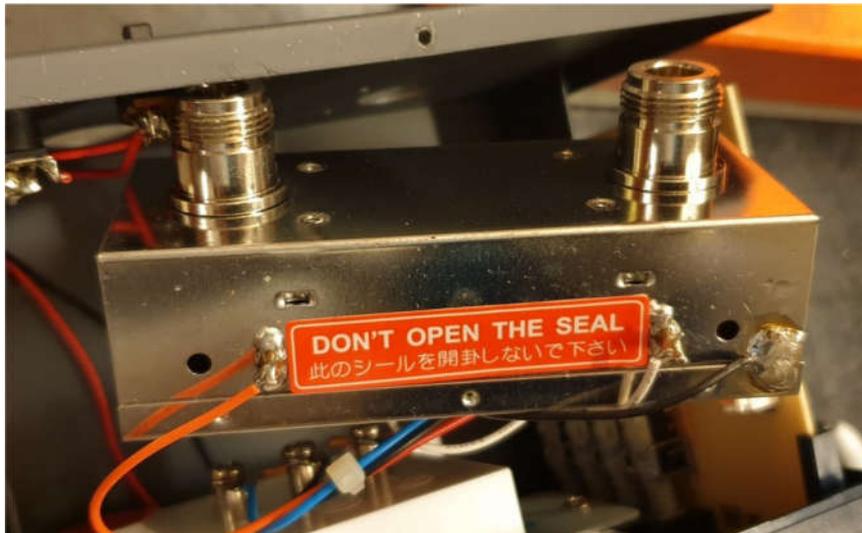
The heart of the instrument is the directional coupler I took out from the box:

The unit is hosted in a tinned steel box with a red seal label covering a long slot in the upper wall of the box. I left in place the label and removed the cover after having taken away the solder seal put on its right side.
